Characterization and Modeling of ESD-Behavior of Multi Layer Ceramic Capacitors

Stanislav Scheier, Stephan Frei
TU Dortmund University
Dortmund, Germany
stanislav.scheier@tu-dortmund.de

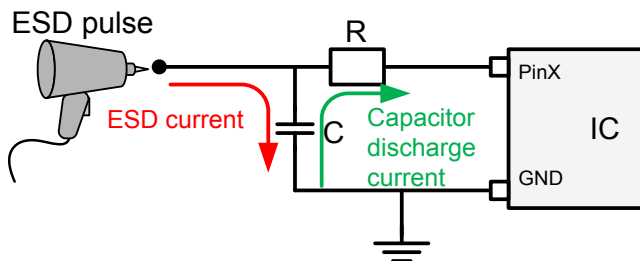
Fig. 1. ESD protection by RC-filter

To avoid ESD failures on system level in many cases protection strategies are applied. A simple method is to equip the PCB with discrete protection components. Frequency selective elements like a Multilayer Ceramic Capacitor (MLCC) sometimes combined with a resistor are a common off-chip ESD-protection strategy to avoid ESD-problems. Due to its low cost and suitability as EMI-protection the capacitors play a leading role compared to other ESD-protection elements like nonlinear special devices. When a resistor is connected in series to the IC pin, the discharge current can be limited further.

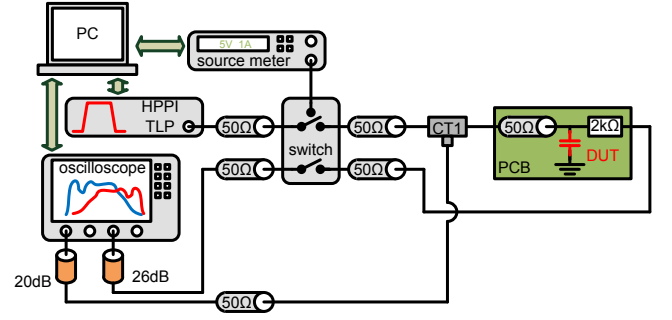
Fig. 2. Measurement setup for MLCC characterization

A TLP can be used to measure the high voltage behavior of components in time domain [5]. The TLP creates a high voltage pulse. Some properties are comparable to real ESD events. Due to short pulse length, released energy is relatively low and device characterization for voltages far beyond the specification range is possible, without the risk of thermal damage. The setup in Fig. 2 is adopted for MLCC characterization. When applying the TLP-pulse (HPPI- TLP/VF-TLP/HMM Test System TLP-3010C) to a DUT, voltage and current shapes are recorded by a 6 GHz oscilloscope (LeCroy WavePro 7 Zi) by voltage divider and a current sensor (Tektronik CT1) respectively. A source meter (Keithley 2400) is used to detect permanent damages on the insulation resistance after every TLP pulse. Any damage to the measuring instruments is avoided by attenuators.

The setup in Fig. 2 is simulated in VHDL-AMS. The model for TLP generator has been presented and verified by measurement with different low and high-ohmic loads in [7]. Fig. 14 and Fig. 15 compare simulated and measured curves for an 800 V TLP pulse. Absolute maximum ratings are violated and as a result, saturation may be observed. The transition to steady state is almost perfectly reproduced. The current maintains above zero, because of the parallel resistor of 2050 Ω. Low pass filtering of measurement data is applied for noise reduction.

element is loaded with IEC ESD pulses. The setup shown in Fig. 2 is used. ESD current is measured with a Tektronix CT1 current probe. A parallel $10\text{ k}\Omega$ resistor is used to provide a discharge load. Additionally, it provides a discharge path for MLCC between consecutive IEC-pulses and ensures proper initial conditions of MLCC. The ESD current is measured only. A simulation of an ideal 4.7 nF capacitor is included to highlight the extent of nonlinearity for real MLCC.

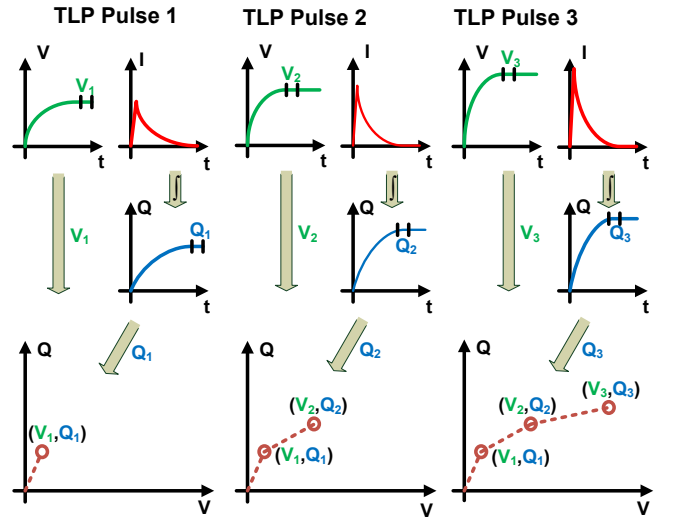
Fig. 3. Measurement process for capacitor characterization by QV-curve with TLP. TLP charging voltage is increased from pulse 1 to pulse 3.

A cumulative integral function is used to obtain a charge over time curve. The voltage and charge values for a particular TLP charging voltage are detected in saturated state. Fig. 3 illustrates measurement process described above.

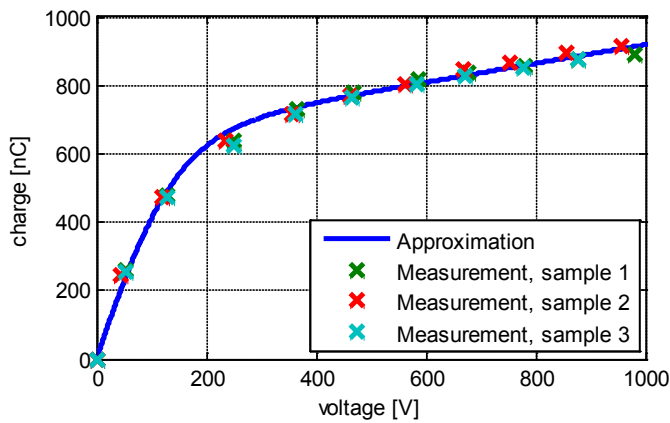
Fig. 4. Comparison of measured and fitted QV-curve

Fig. 4 compares fitted and measured QV-curves. Fig. 5 applies the fitted coefficients of the QV-curve to (6) and compares it with a discrete differentiated QV-curve. The tolerance within a set of MLCCs is presented too. The behavior of three samples is nearly the same. Damage on insulation resistance was measured between 900 V to 1000 V.

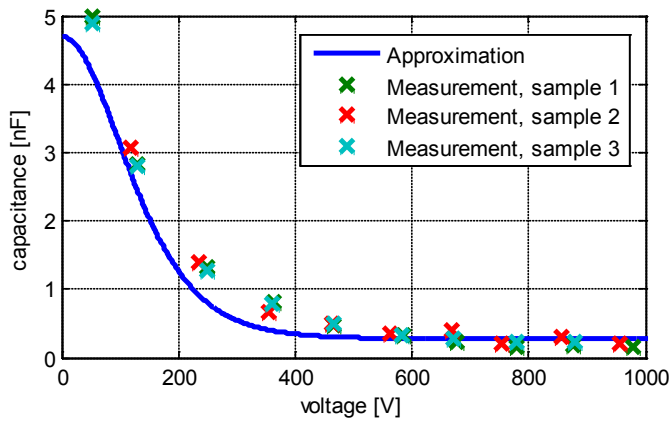
Fig. 5. CV-curve applies the fitted coefficients of the QV-curve to (6)

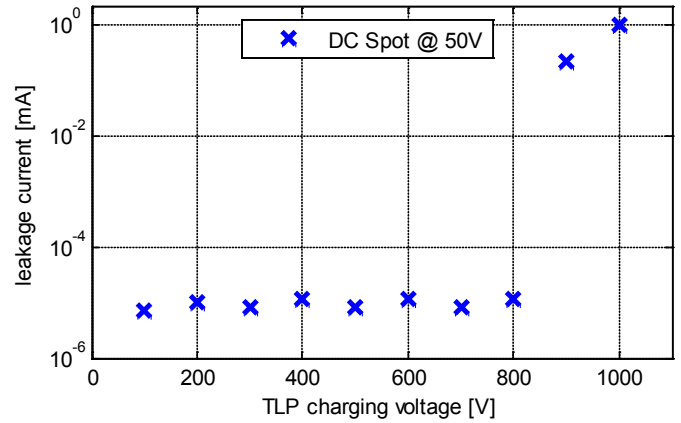
Fig. 6. DC spots of the leakage current

After a physical damage on insulation resistance has taken place, a change in leakage current of more than a decade is

observed. For the studied sample a critical voltage of 900 V can be measured (see Fig. 6)

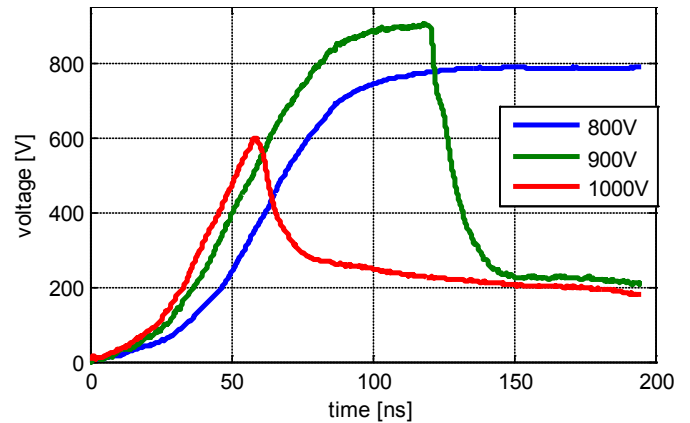
Fig. 7. Measured voltage shapes. Low pass filtering is used for noise reduction.

Voltage curves of a measurement with TLP pulses for an increasing charging voltage are shown in Fig. 7. Only a single pulse was assigned for every voltage level. The MLCC withstands 800 V TLP pulse. 900 V is the critical voltage for insulation breakdown. This pulse cause damages and the voltage drops rapidly after 130 ns. Over the pre-damaged MLCC a 1000 V pulse is applied. At the beginning no changes in MLCC behavior can be observed. However, the critical voltage of the pre-damaged MLCC is considerably lower than the voltage of the faultless one. These results clearly state that the voltage on a MLCC is the critical parameter for the first failure.

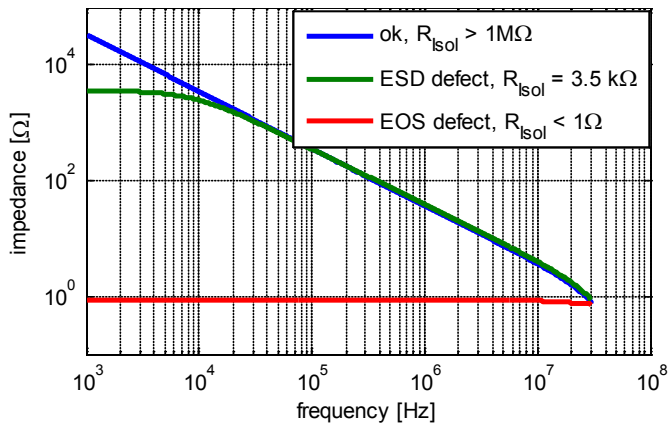
Fig. 8. Impedance analyser measurement of a non-damaged MLCC, a MLCC after ESD failure, and an ESD-damaged MLCC after an EOS failure

Fig. 8 shows the impedance analyzer measurement of the MLCC. The damaged device shows similar frequency response like the faultless one. The difference is caused by the change of the insulation resistance, where a drop from around 1 MΩ to 3.5 kΩ is measured. Capacity measurement at 13.5 MHz results in 4.42 nF for the faultless and 4.13 nF for the damaged MLCC. This means 7 % degradation in RF properties. In addition, Fig. 8 provides a measurement, where the damaged capacitor was analyzed with a 30 V DC-offset. This condition leads to an Electrical Overstress (EOS) failure of the capacitor, where it becomes permanently conducting. Capacitive behavior cannot be seen any more and a short circuit of less than 1 Ω is measured.

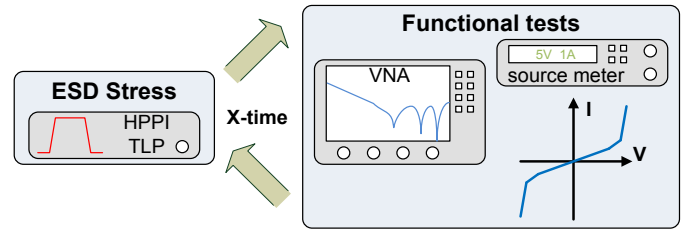
Fig. 9. Measurement process for degradation characterization

As already shown, TLP pulses of 900 V to 1000 V are critical for the investigated MLCC. The effects were examined in two test series, by 700 V as a high, but assumed to be safe voltage and by 1000 V as a critical voltage. Measurement process is illustrated in Fig. 9. It is carried out by repetition of the following three steps:

1. High voltage stress: The MLCC is stressed by a certain number of TLP pulses of 200 ns length and 1.1 ns rise time. A permanently connected parallel 220 kΩ resistor is used to discharge the capacitor. No kind of degradation was measured on resistor.
2. Measurement of RF properties: impedance of MLCC is measured with vector network analyzer (VNA, Agilent E5061B) in frequency domain. Before measurement, VNA is calibrated and cables connecting the test PCB are de-embedded. Measurement range is between 1 kHz and 1 GHz.
3. Measurement of insulation resistance: a source meter (Keithley 2400) is used to detect permanent damages on insulation. Current range (10 pA-1.05 A) is much higher in comparison to VNA. Voltage sweep is performed from 1 V to 50 V. Maximum source current is limited to 10 mA, to prevent damages.

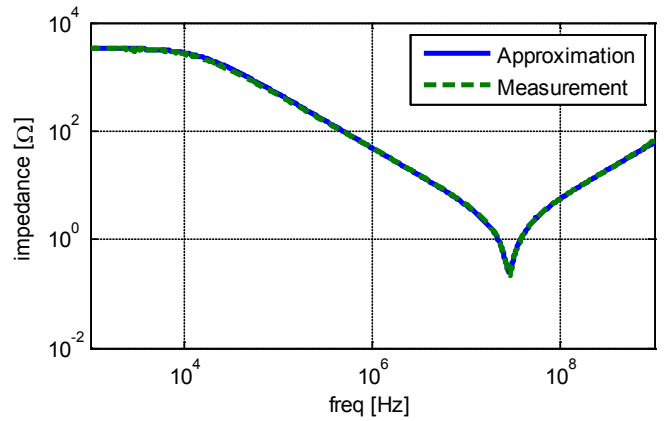
Fig. 10. Approximation of the measurement after 1000 TLP pulses with 1000 V. $C=3.22$ nF, $L_{ESL}=9.6$ nH, $R_{ESR}=240$ mΩ, and $R_{isol}=3.3$ kΩ

For parameter extraction measured impedance, after certain number of pulses, was approximated by model in Fig. 13. The parameter R_{isol} was set to the corresponding result by source meter at 1 V. The parameters C , R_{ESR} , L_{ESL} were tuned to match with the measured impedance.

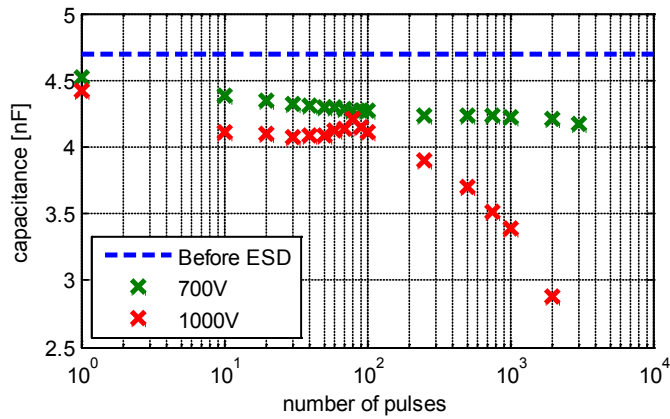
Fig. 11. Degradation of capacitance. The results are normalized to 4.7 nF as initial value of every MLCC.

Fig. 11 and Fig. 12 demonstrate the degradation results. For 700 V test series low voltage capacitance is decreasing strictly monotonic with additional pulses. For that effect some ferroelectric properties of the ceramic material may be responsible. Exposure of MLCC to voltages far beyond maximum ratings may lead to an asymmetrical shift in the equilibrium ion positions. This may cause a permanent dipole moment and hence a non-zero remanent polarization. Electric fields at normal operation are not strong enough to reverse that effect. However, no change in insulation resistance is visible. That means the degradation affects only the low voltage part of the QV-curve (5) and the ESD robustness of the MLCC remains quasi static.

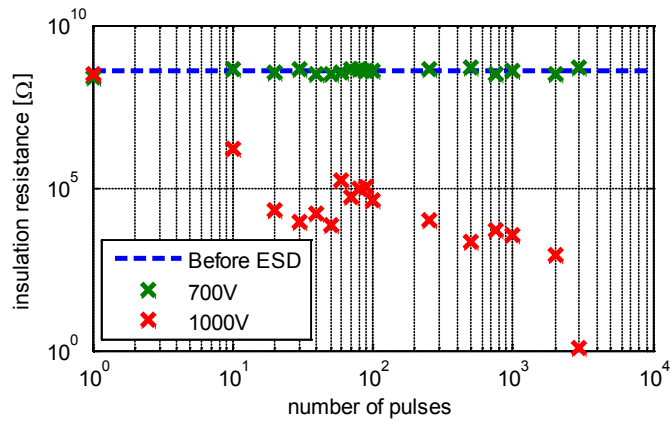
Fig. 12. Degradation of insulation resistance

As expected, insulation breakdown is observed after 10 pulses by 1000 V test series. As a result of metallization of conductive plates within the MLCC, insulation resistance falls by more than a decade. In general it continues to fall with additional high voltage pulses. However, the process does not behave consistently. The low voltage capacitive properties are affected by the mentioned process and the remanent polarization of the ceramic itself. After 3000 pulses a short of about 1 Ω is observed. No capacitive property can be measured anymore. In both test series no significant change in R_{ESR} and L_{ESL} was measured. TABLE I summarizes the degradation effects.

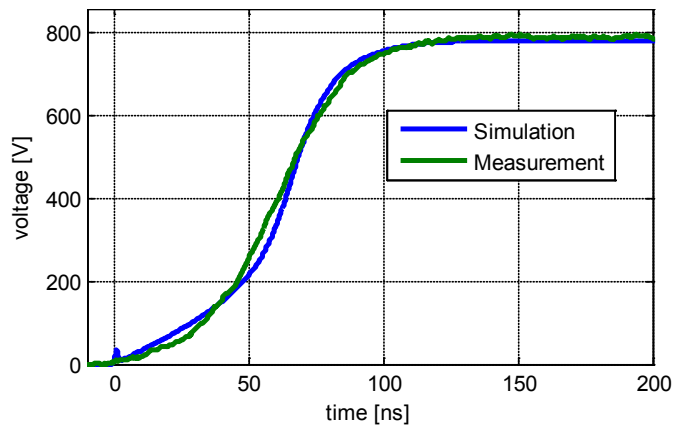
Fig. 14. Simulated and measured voltage for 800 V TLP pulse

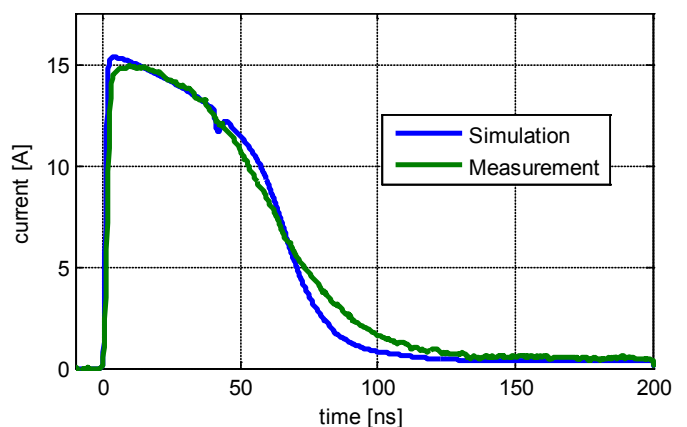
Fig. 15. Simulated and measured current for 800 V TLP pulse

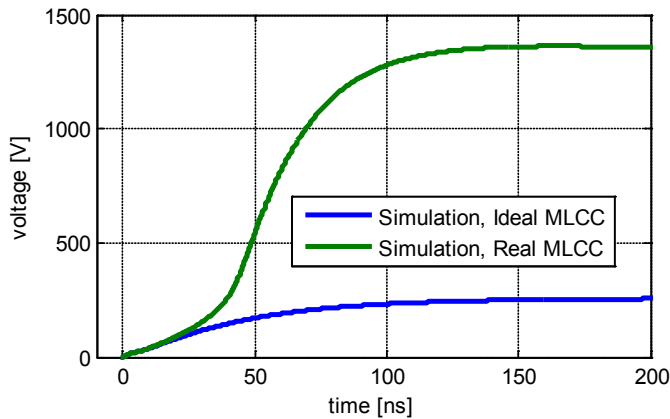
Fig. 17. Simulated voltage for 8 kV IEC ESD pulse

Simulation shows an insulation breakdown at 63.8 ns . In measurement a MLCC failure is observed at about 100 ns . The MLCC becomes conductive and a rise in ESD current is measured. After the ESD stress, an isolation resistance of $8\text{ k}\Omega$ is measured. There is a significant difference in voltage level on real and ideal MLCC. This result highlights the need of an accurate MLCC model with regard to transient high voltage behavior for reliable ESD simulation.

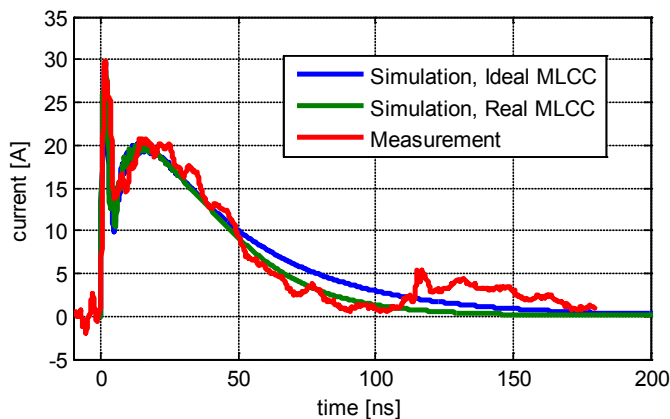
Fig. 18. Simulated and measured current for 8 kV IEC ESD pulse
